Technical paper

Degradation of Plasticized Poly(1-chloroethylene) Waterproofing Membranes used as a Building Material

Gregor Kravanja,^{1,2*} Andrej Ivanič² and Samo Lubej^{2*}

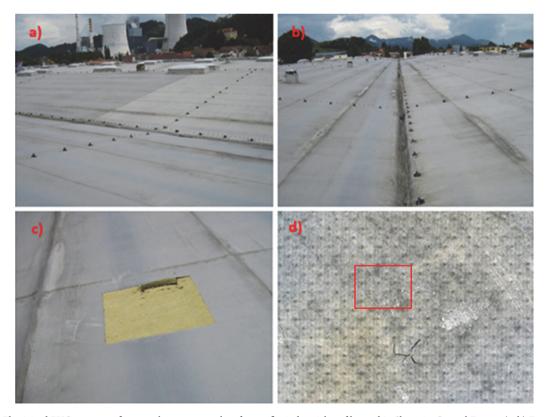
Figure 1. Plasticized PVC waterproofing membranes were taken from a flat industrial roof located in Slovenia, Central Europe (a, b) Extraction at sampling location 1 (c). Naturally aged and locally damaged plasticized PVC membrane (d).

SR, Soprema, Italy) were obtained from the unvented roof of an industrial building located in Slovenia, Central Europe, which is characterized by a Cfb climate zone (Figure 1 a,b,c). Membranes are made of 51% pure PVC, 46% additives and 3% reinforcing material. The roof construction consisted of several layers: on top, a 1.2 mm thick plasticized PVC membrane; below, a 200 mm thick layer of thermal insulation with a density of 150 kg/m³, followed by a 0.3 mm thick vapor barrier and trapezoidal sheet metal cladding anchored in steel roof beams (Appendix 1). An inspection revealed that the waterproofing membranes were damaged at several points where the photovoltaic modules were installed; the damage was visible as starshaped cracks (Figure 1. d).

Samples exposed to natural outdoor weathering were taken from various sampling locations, as shown in Appendix 2. Location 1 is an area with many visible starshaped cracks on the surface of membranes. Location 2 is an area where a strong colour variation of the membranes was observed. Location 3 is a softening roofing area where a significant deterioration in the strength of the insulation has been observed. Plasticized PVC membranes were taken from each of these roofing areas, immediately wrapped in polyethylene, and transported to the laboratory for further analysis.

systems over thermal insulation. During 10 years of use, plasticized PVC gradually degraded, and its primary physical, chemical and mechanical properties changed. This tendency was observed in all three sampling locations. Therefore, the roofing area had to be completely replaced. The main conclusions are:

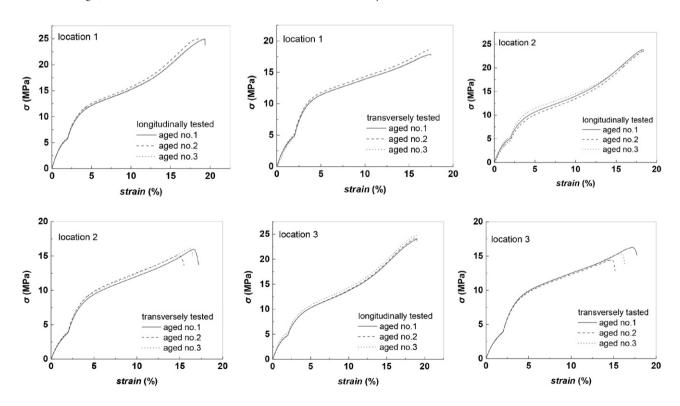
On the other hand, the strength of aged membranes decreases in the transverse directions compared to the strength of a new membrane. As shown in Table 1, aged membrane samples showed a shorter elongation at break than that of the new membrane. This indicates a loss of flexibility caused by natural aging under high humidity and thermal fluctuations. The deterioration in elastic properties is caused by the loss of plasticizers as a result of a long period of combined exposure to heat from solar

Figure 3. Tensile strength and elongation at break (load/strain curves) for aged, plasticized PVC membrane samples tested longitudinal (left) and transverse (right) directions at conditions: $T = 393.15 \pm 2$ K, RH (relative humidity) = 50 ± 5 %.

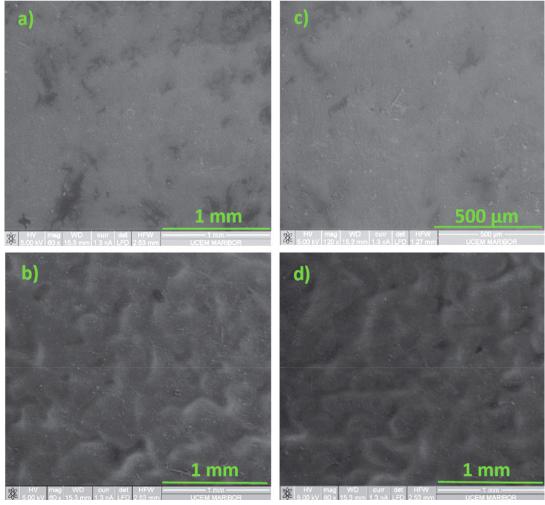
Microphotographs of new and aged membranes taken by SEM show significant differences between them. As shown in Figure 4, new membranes have a smooth surface, without cracks. Locally, only the grains of filler can be observed. In contrast, aged membranes that have been exposed to natural weathering show irritated surfaces with many cracks, agglomerates and craters as a result of plasticizer loss. The material becomes stiffer, which leads to

$\textbf{Figure 4}. \ \ \text{Microstructure of new membranes' upper layer (a, c) and lower layer (b, d)}.$

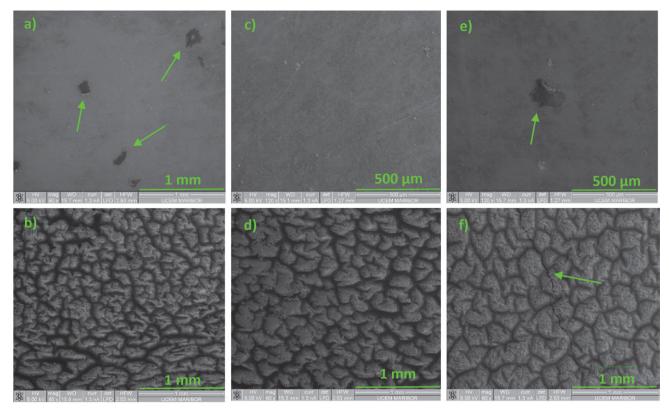
Figure 5. The microstructure of aged membranes extracted from different sampling locations: 1 (a, b), 2 (c, d), and 3 (e, f). The surface is more heterogeneous, with many craters, cracks, agglomerates, and voids.

contractions and the prevalence of voids (Figure 5). It is assumed that the rearrangement and aggregation of molecular chains are the main mechanisms of membrane degradation.¹⁹ Pedrosa et al.²⁰ presented an interesting study using X-ray spectroscopy and SEM analysis of membranes exposed to different weathering conditions. They reported that aged membranes show numerous cracks and fractures and there is a significant decrease in chlorine content. Therefore, they suggested that dehydrochlorination may be the main mechanism of deterioration.

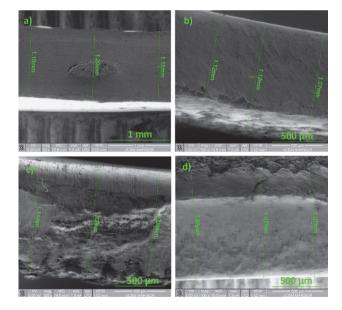
Cross-sectional microphotographs with thickness evaluations of the investigated plasticized PVC membranes are presented in Figure 6 and Table 6. It can be seen that the thickness of the aged membranes is decreased. As can be seen in Figure 6, there is also a visible difference in cross-sectional area between new and aged membranes.

Figure 6. Microphotographs in cross section with thickness evaluation for new membrane (a) and aged membranes (a, b, c).

For example, the average thickness values for location 3 decrease from 1.18 mm to 1.09 mm. Changes in material thickness might be because of the reduction of plasticizer content. To justify plasticizer loss in material, chemical changes were identified and quantified using ATR/FTIR analysis.
